# #25-NA-158: No Shift, Transmission in Default, only has Fifth Gear and/or Reverse, Malfunction Indicator Lamp (MIL) Illuminated - DTC P0747 Set - (Aug 18, 2025)

**Subject: No Shift, Transmission in Default, only has Fifth Gear and/or Reverse, Malfunction Indicator Lamp (MIL) Illuminated - DTC P0747 Set**

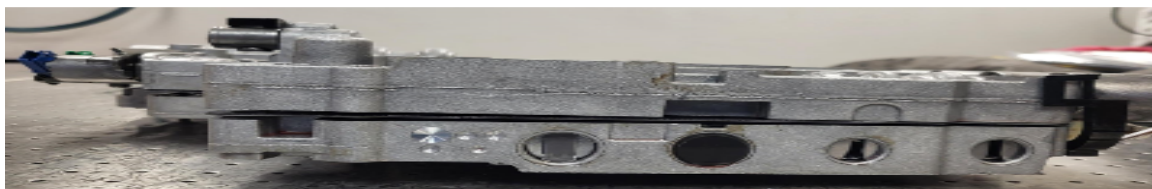
**Important:** Do not use prying devices to separate the valve body halves.

9. Using care, lift the solenoid body to separate the solenoid body from the control valve body. Some light shaking may be required.

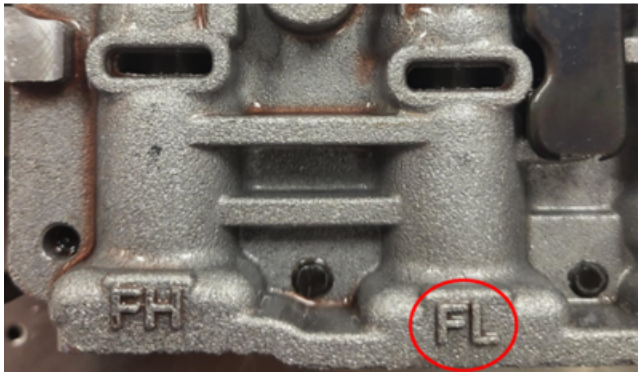
– On the un-machined side of the control valve, the feed limit low valve is identified as FL.
