Service Action

Code: 91MM

Infotainment System Software

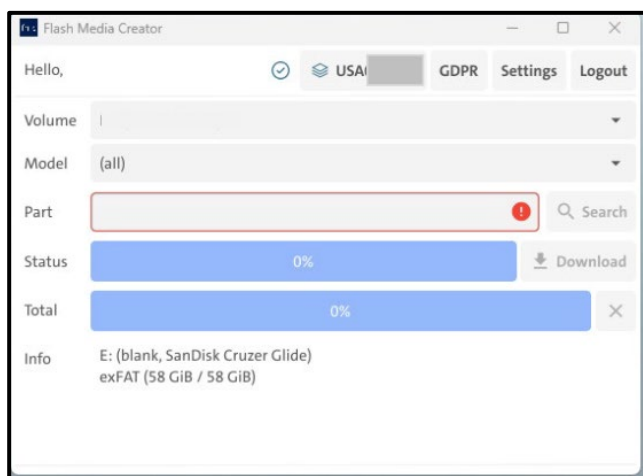
Required USB Drive

- The required software will have to be downloaded onto a USB drive using the Flash Media Creator (FMC).

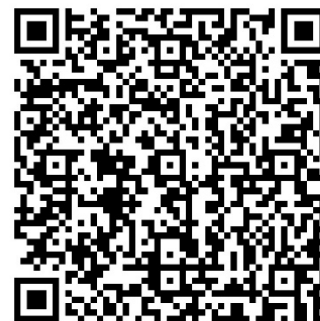
- For the new software update program, the following SVM code must be entered exactly, including commas and without spaces (recommendation: scan QR code with hand-held scanner or copy and paste the SVM code chain).

**91MMA521,FLIGHTON0075MLB,TGU1MDMVB,CL35A001MLBNAR,ZGDOIP,
CL35A002MLBNAR,CL35A003MLBNAR,FLIGHTOFF0075MLB**
